Manhole Inspection Summary

Manhole # S29E__019MH

Location Address: **630 Fayette St**

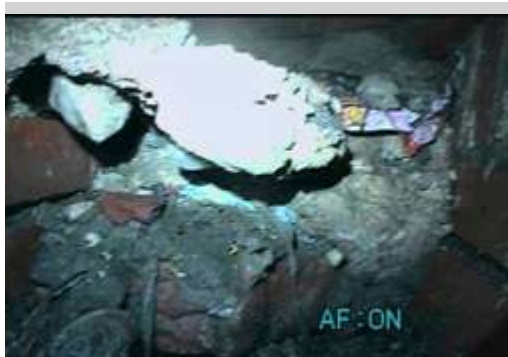
Defect

☒ **Debris**

channel Debris

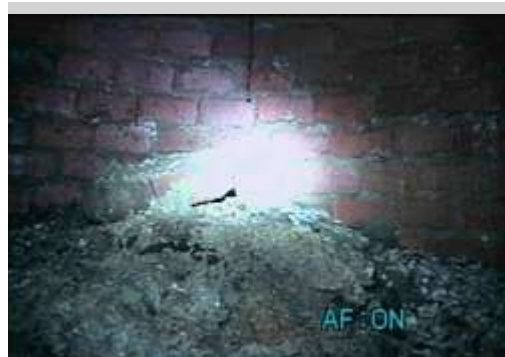
Defect 4

☒ **Debris**

bench debris

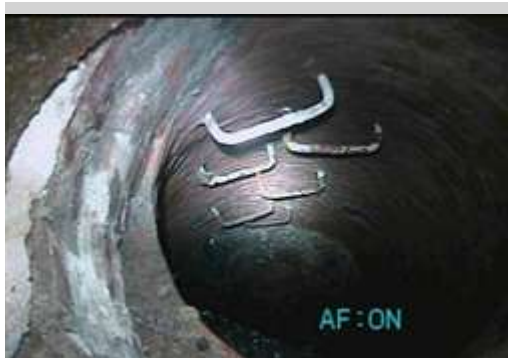
Defect 3

☒ **Corroded**

steps

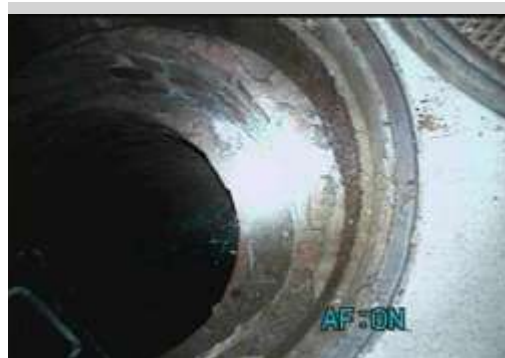
Defect 2

Offset: **6** (in.)

☒ **Cracked**

off set frame

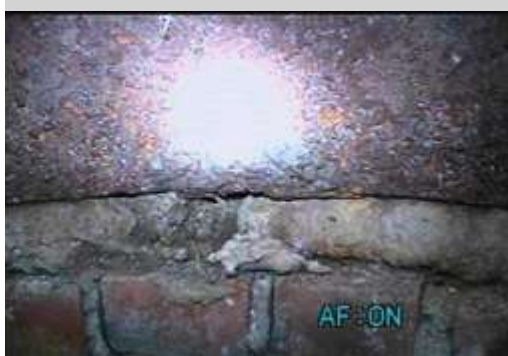
Defect 1

☒ **Loose Brick**

☒ **Deteriorated**

chimney_cond_deteriorated ,
chimney_cond_loose_bricks

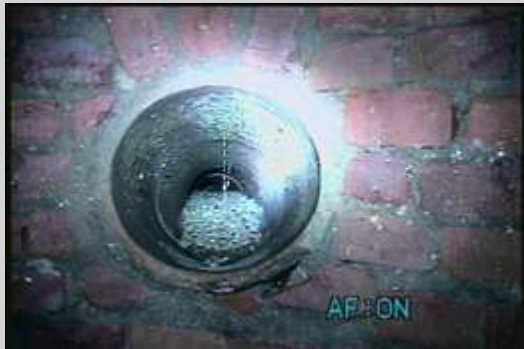
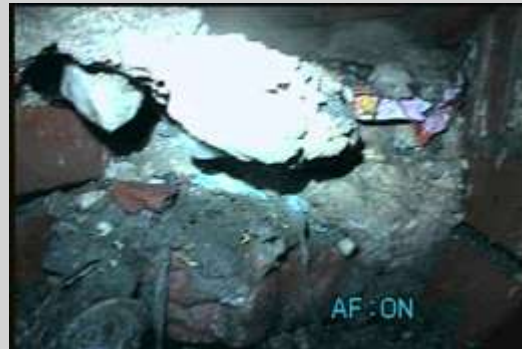
9 O'Clock Inflow

debris covering pipe

Drop Condition: **Clogged**
